**Diesel line operating at 900 psi; Exxon, Caribbean off coast of Belize, 2008**

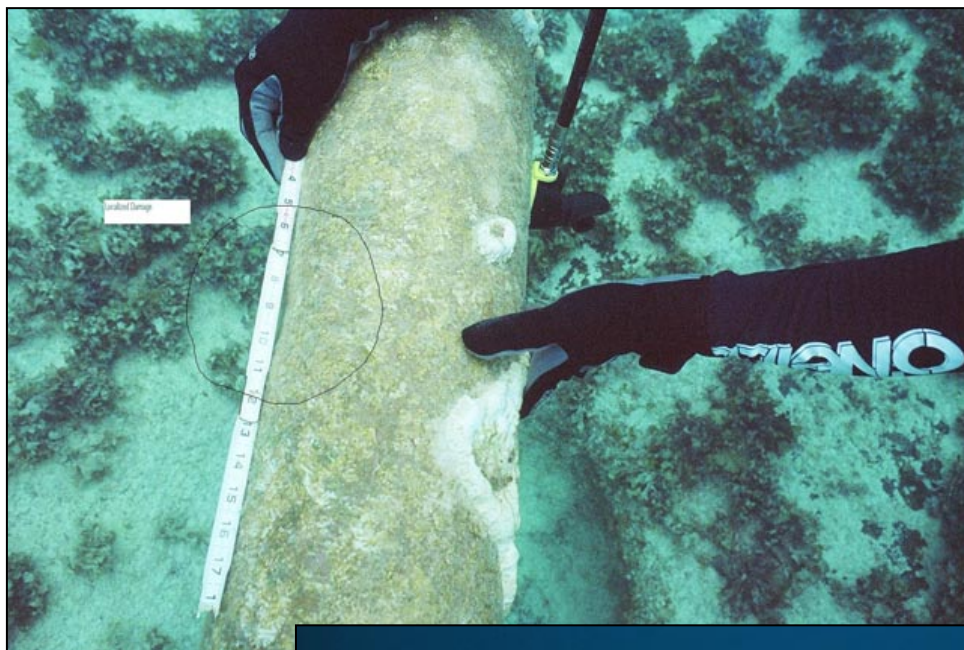
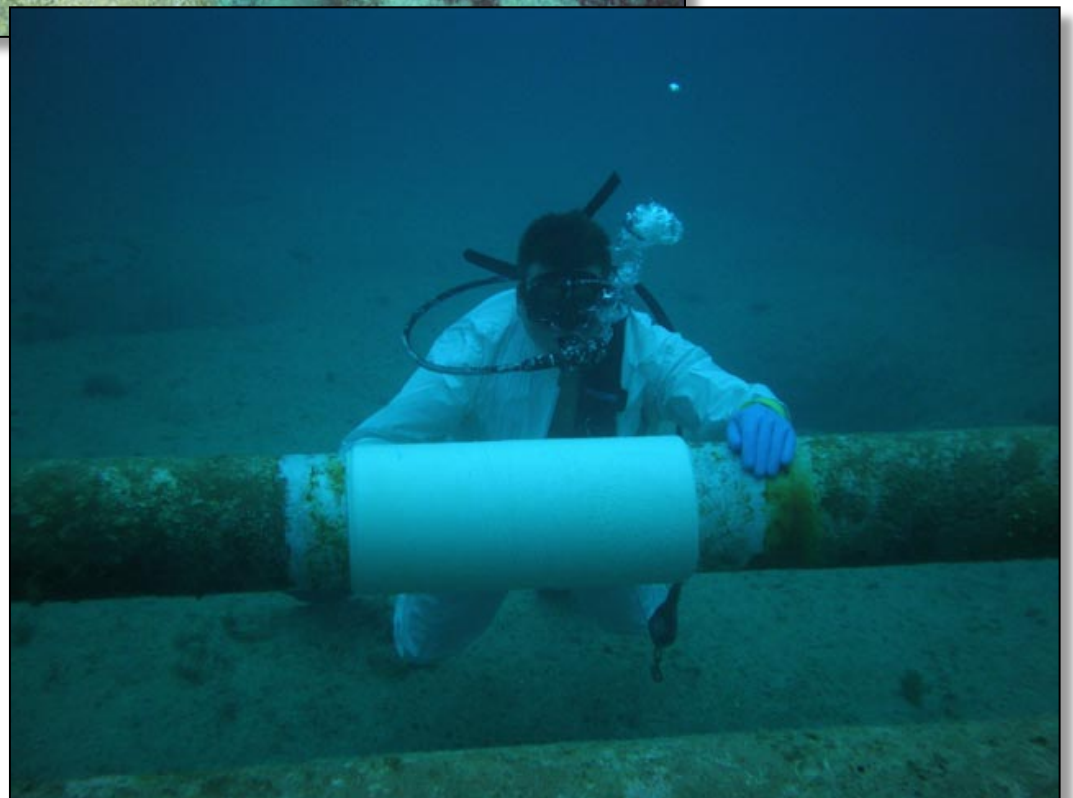
Dent damage due to anchor drag;

Surface hand prepared, dent filled with high compressive strength epoxy filler to re-contour pipe and repaired with Aquawrap system.
