## **Concrete Column Repair**

### Emergency Bridge Column Repair

The New York State Department of Transportation, District #6 (NYSDOT), operating under an emergency repair contract, effected repairs on Bridge no. 7012680 and 7012690 on Route 17 in Painted Post, New York.

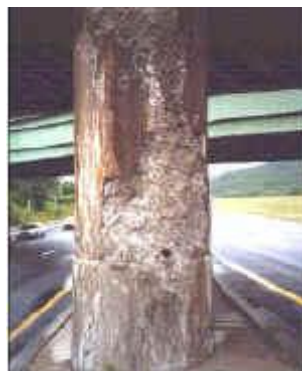
The bridge, built in 1952, was structurally sound but was exhibiting serious spalling on the columns. This bridge supports the Norfolk Southern Railroad over Route 17. The bridge consisted of four columns that were approximately 5 feet in diameter and 12 feet high. They were damaged primarily due to weathering, freeze/thaw cycling, and the use of salt in winter conditions.

External damage to concrete column

The NYSDOT elected to use Aquawrap® for the repair of the columns supporting the bridge. The columns were first patched using cementitious materials. The column's shape was restored and the installation process began.

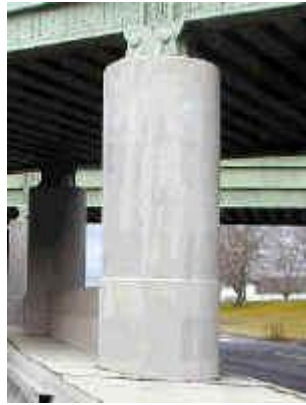
Filler material used to restore shape

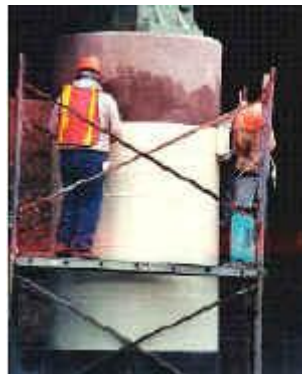
Aquawrap® G-05 Installation

The first layers consist of Aquawrap® G-05, which is a heavy 22 oz. fabric. This is later covered with the G-03 fabric, a much tighter weave that provides a smooth surface.

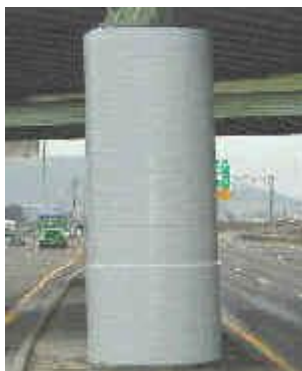
Completed Installation

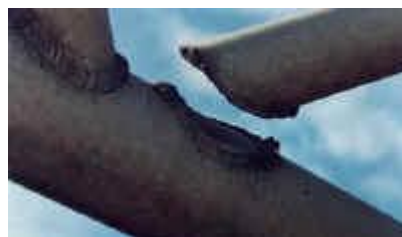
Several states utilize welded aluminum structures to support freeway and throughway signage. These structures are continuously battered by wind and vibration loads, freeze-thaw cycles, and other environmental conditions. These extra loads have put undue stress on the welds which has caused them to be damaged. In some cases, the welds at the joints of these structures have either partially or fully cracked. The exact failure mechanism has not been isolated, but the need to reinforce them is urgent.

Cracked Weld in Sign Structure

In cooperation with universities and state agencies, Air Logistics has developed and tested a field applied FRP repair system which is currently in use to repair the cracked joint welds. Several joints with cracked welds were cut from dismantled sign structures and repaired with the FRP repair system. These samples were tested at the University of Utah in a series of tension tests and proved to be as strong as sound aluminum welds.

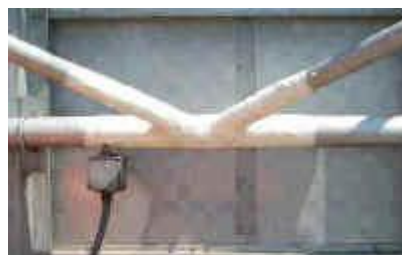
Aquawrap® Installation

A thorough field procedure has been developed and implemented for this repair. Surface preparation is crucial, and the procedure includes specified cleaning chemicals, abrasives, and safety gear. By using a kit concept, all the materials needed to do the job are readily available. Technicians are trained and certified for installations and most jobs can be done in less than one day.

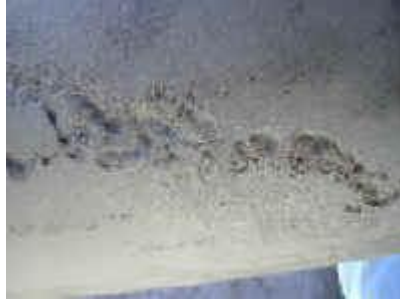
The line shown here was a 24" natural gas line that normally operates upwards of 900 psi. During normal inspection procedures, this section of piping was found to have severe corrosion pitting, nearly 80% wall loss in some areas. This condition required an immediate repair.

Corrosion pitting was nearly 80% deep

After sandblasting to a NACE No.2/SSPC-SP10 finish, the pitted areas were filled with a high-compressive strength load-transfer compound. This is used to transfer the load of the piping to the composite material as the damaged area reaches its yield point.

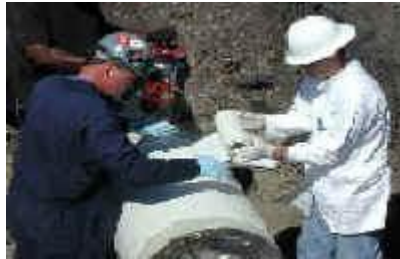
Aquawrap® being applied around pipe

Our BP-1 Primer System was applied over the entire repair surface to provide an interface between the steel and the composite. When tacky, the installation of Aquawrap® began. Using in-house design calculations, the proper amount of layers were installed to bring the pipeline back to the required strength.

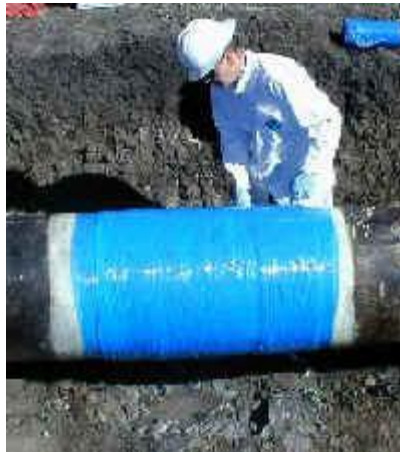
Stricture Banding™ is used to compress and consolidate the composite

When all the layers have been applied, Stricture Banding™ is used to compress and consolidate the installation. This process forces air out of the installation, allowing a solid composite lay-up to be formed. After a 1-hour cure time, the Stricture Banding™ was removed and the line was coated with a standard pipe tape material.

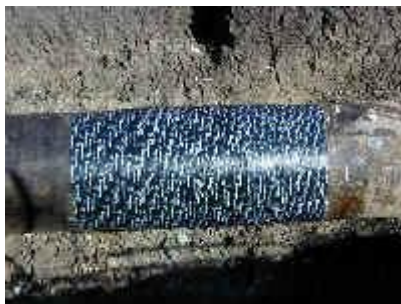
Final Result

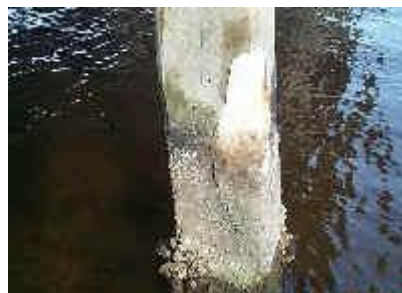
Steel reinforced concrete bridge and pier pilings are subject to splash zone damage in both fresh and salt water areas (Figure 2). The damage to the concrete is usually caused by abrasion or impacts by wave and tidal action, collisions with marine vessels, and normal spalling. In addition, oxygen and water penetration can cause corrosion of the reinforcing steel.

External cosmetic damage to concrete pile

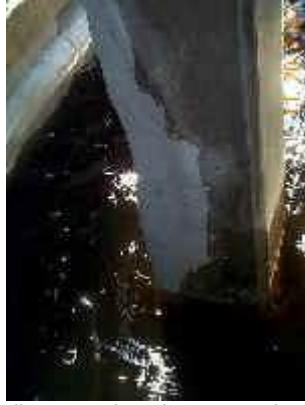
Filler material used to restore shape

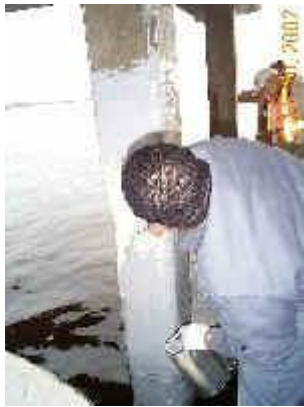
Final protective coating applied

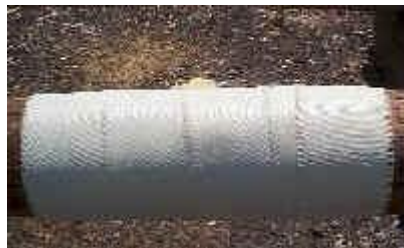
Initial Layer of Aquawrap<sup>®</sup> G-05

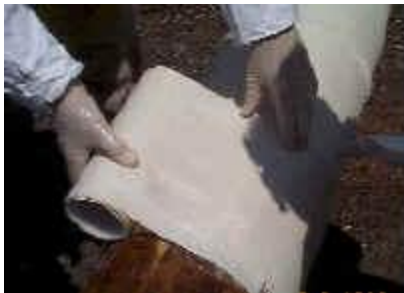
Simple Installation

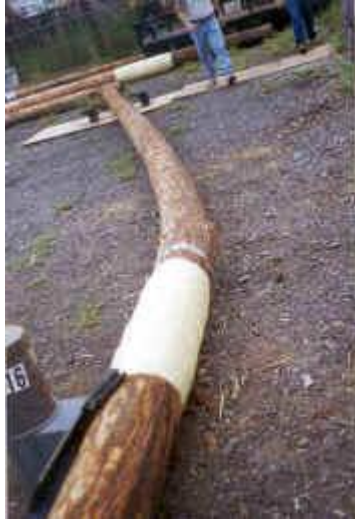
Although many laboratories and customers have test Aquawrap® in almost every conceivable way, the pole manufacturer had to have hard data on the performance when applied to old, weathered, treated wood poles. The tests showed that a severely damaged pole can be rebuilt in the field, using Aquawrap® and when subjected to enough bending load, the pole would always break somewhere out in the "good wood" areas, away from the repair.

Pole Bent to Test Strength

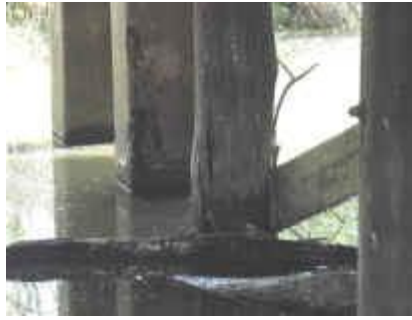
A transportation department had found some timber piles under a bridge that had suffered compression damage. In some cases, the piles were completely holed through and the pile provided no support at all. Reinforcement was required to keep the pile from completely breaking in two pieces.

Damaged Timber Pile

A special application of Aquawrap<sup>®</sup> was chosen to strengthen and reinforce the pile. First, our BP-4 Primer/Coating was applied to fill in small cracks and voids. BP-4 can be applied in dry and wet conditions and cures in about 2 hours. Large voids were left open in preparation for grout injection. Next, Aquawrap<sup>®</sup> was installed around the pile, covering all damaged areas, above and below the water line. The composite was allowed to set up, about 2 hours, and then the injection process began.

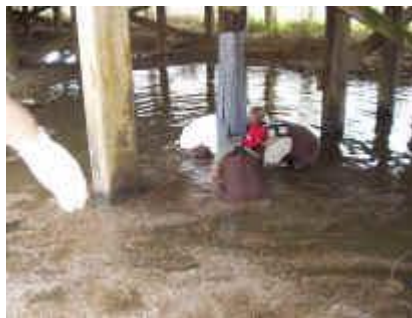
First Layer of Epoxy Coating

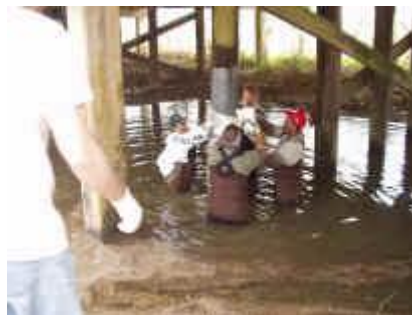
Aquawrap® Installation

Starting at the bottom, small holes were drilled into the composite every 12". A high compressive strength epoxy grout was then injected into the column to provide a solid structure. Air and water were pushed out of the voids as the epoxy was injected from the bottom up. This continued until the column was full. The injection process was closely monitored for heat buildup from the epoxy reaction. If too much epoxy was injected at once, the exotherm could cause shrinkage and damage to the repair.

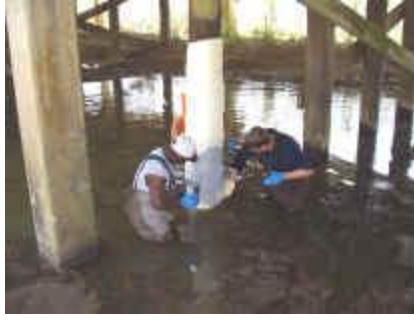
Final Layer of BP-4 Coating
