# 激光熔覆技术典型案例:1)芬兰Fortum:修复汽轮机低压缸末级腐蚀的革新技术

#### Fortum - Finland,

#### Laser cladding of steam turbine casing

#### July 2016

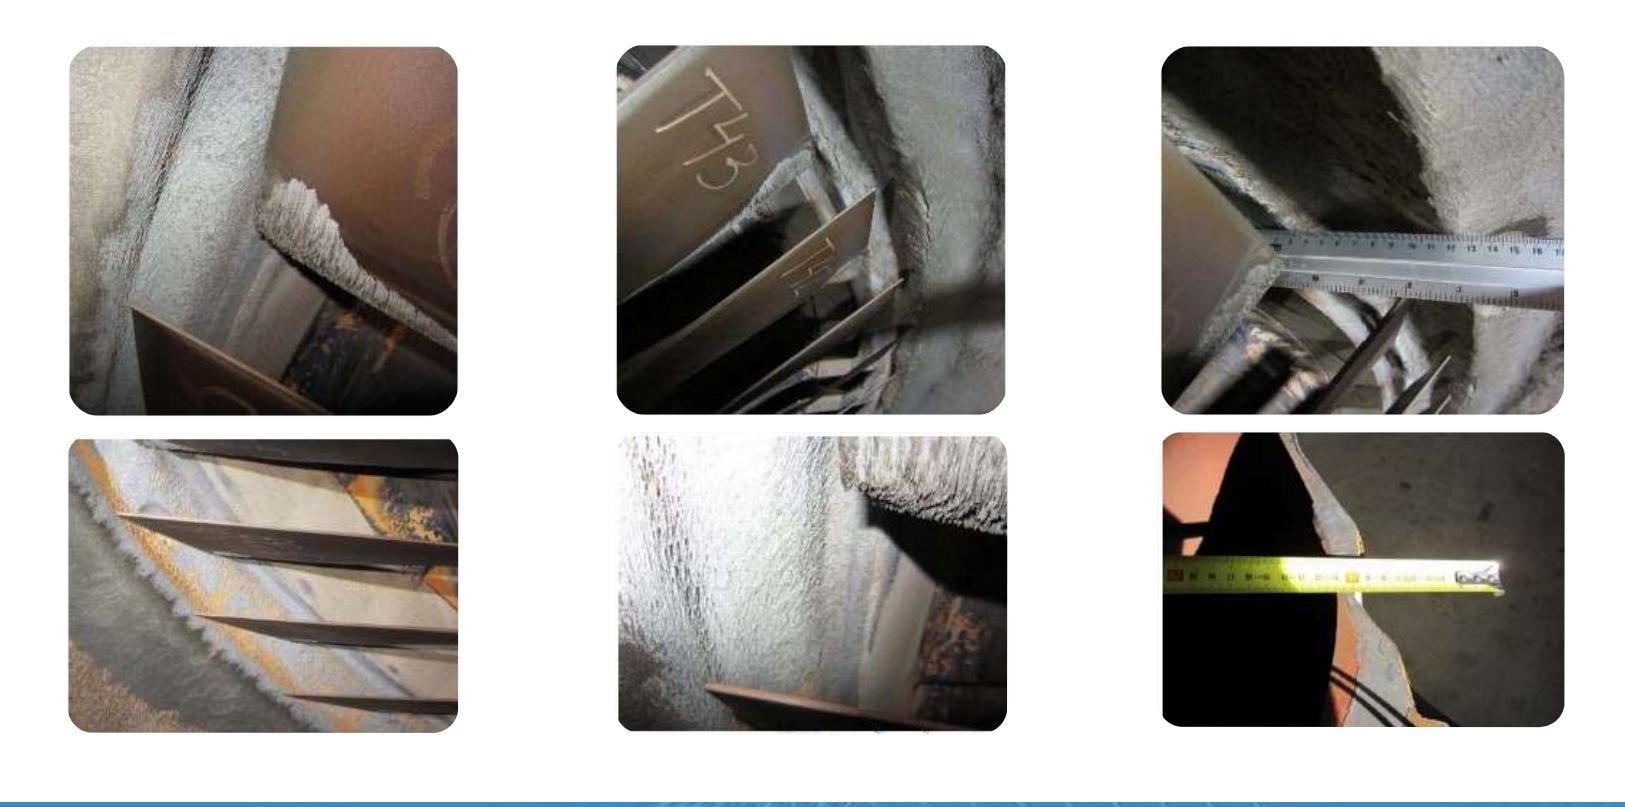
• A common problem on (low pressure) steam turbines is the development of erosion damage at the final stage diffusor area.

Erosion damage develops due to the impact of high velocity water droplets and washing which occurs during the operation of a turbine. 腐蚀的原因是运行期间高速水滴的冲击和磨损.

# Erosion damage at diffuser area 低压缸扩流区域冲刷磨损

- Stork has developed an innovative repair solution using laser cladding to prevent the progression of damage and ensure safe and reliable operations.
   施托克开发了革新的方案,采用激光熔覆技术来防止损坏的 扩展,以确保安全可靠地运行.
- A clad layer with wear resistant properties is applied to the damaged surface of a casing. 在壳体易损区域熔覆一层耐磨材料.
- The mechanical properties of the cladding material create a barrier to prevent the damage from progressing.
   熔覆材料形成一个机械保护层,以阻止破坏的进一步发生.

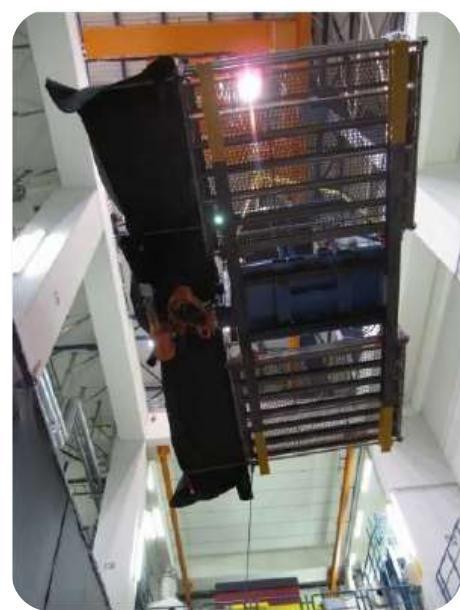
Hoisting the equipment on the casing

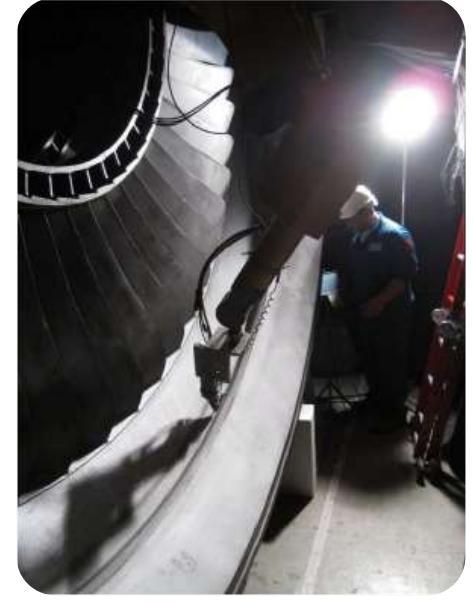
Programming & teaching the robot 机器人程序准备

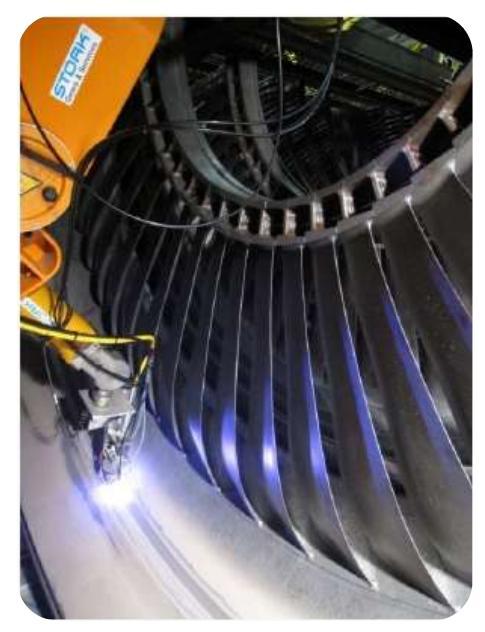
Cladding the casing on-site 现场激光熔覆作业

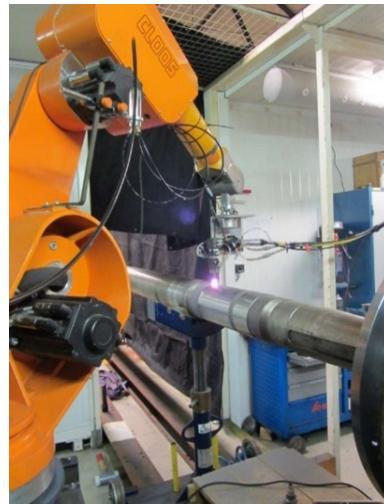
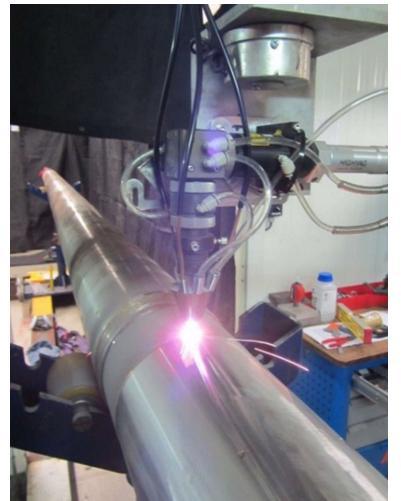
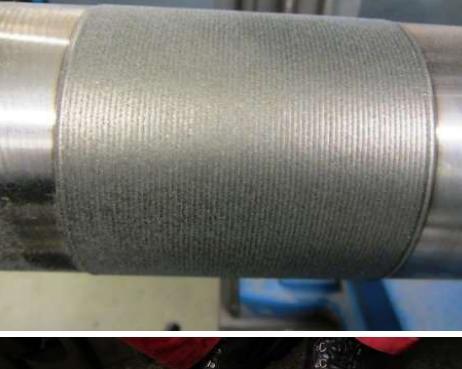
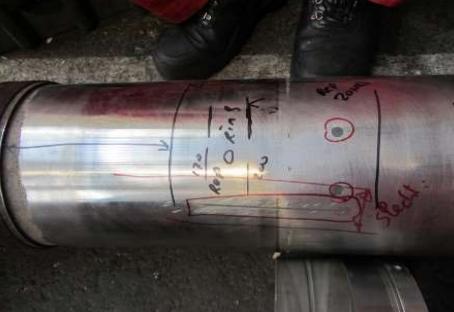
several out of tolerance journals on a long (7600 mm) shaft.

## Challenge 项目描述 Bound overhaul on a pump, the customer identified.

- The shaft was inspected, pre-machined, laser cladded and lathed to the right final dimensions within days.
   短短几天之内,该轴被检测,预加工,激光熔覆,车削,达 到规定的尺寸
- Due to Storks extensive machine shop all repair steps could be carried out consecutively. 施托克的工厂具备各种加工机械,所有步骤按序顺利进行
