### (3) 高塔保温层下CUI腐蚀处理 (涂层/喷砂/保温/脚手架服务)

**Project:** CUI Remediation work on live towers

**Client:** Major Australian operator **Location:** Port Bonython, South Australia

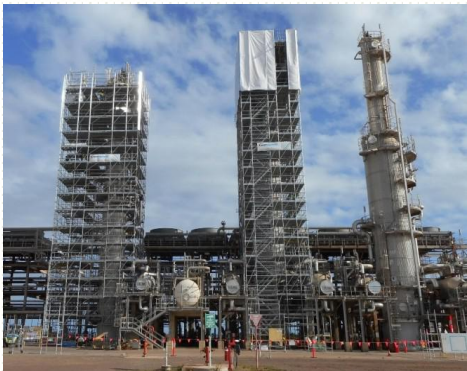
An inspection at a Client gas plant identified substantial corrosion under insulation (CUI) on four towers (de-ethaniser, de-propaniser, de-butaniser, naphtha splitter).

All painting and blasting work was successfully executed on the live towers, which had a temperature range between 10degreesC to 200degreesC.

Abrasive blasting presented a spark risk as the work was being carried out in live conditions. Torbo equipment, which covered the abrasive with high-pressure water, was used to limit any potential sparks and reduce risk.

The towers were located very close to the sea and the area was prone to high winds. This posed a challenge as each tower had to be scaffolded and encapsulated. Giovenco's solution was to use a Keder encapsulation system, which ran on aluminium tracks and was very easy to remove in case of high winds.
