# 激光熔覆技术典型案例:1)芬兰Fortum:修复汽轮机低压缸末级腐蚀的革新技术

#### Fortum - Finland,

#### Laser cladding of steam turbine casing

#### July 2016

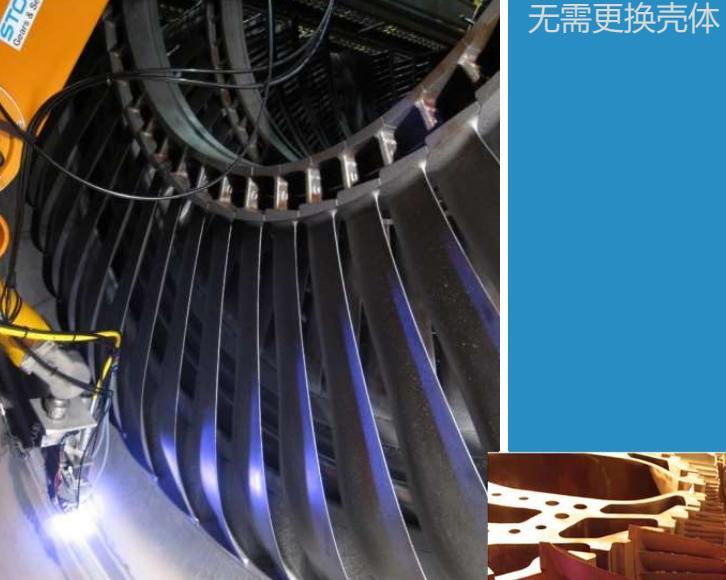
• A common problem on (low pressure) steam turbines is the development of erosion damage at the final stage diffusor area.

Erosion damage develops due to the impact of high velocity water droplets and washing which occurs during the operation of a turbine. 腐蚀的原因是运行期间高速水滴的冲击和磨损.

# Erosion damage at diffuser area 低压缸扩流区域冲刷磨损

- Stork has developed an innovative repair solution using laser cladding to prevent the progression of damage and ensure safe and reliable operations.
   施托克开发了革新的方案,采用激光熔覆技术来防止损坏的 扩展,以确保安全可靠地运行.
- A clad layer with wear resistant properties is applied to the damaged surface of a casing. 在壳体易损区域熔覆一层耐磨材料.
- The mechanical properties of the cladding material create a barrier to prevent the damage from progressing.
   熔覆材料形成一个机械保护层,以阻止破坏的进一步发生.
