COMPOSITE REPAIR

HELIDECK WALKWAY 海洋平台漏水修补案例

- **Project Information**
- **When:** August 2013
- **Location:** North Sea platform
- **Workscope:** Delivering a composite repair solution for a helideck walkway damaged by a water leak
- **Installation:** Stork PowerSleeve
- **Materials:** PowerSleeve and Bio-Dur 563
- **Safety:** Project delivered without an LTI

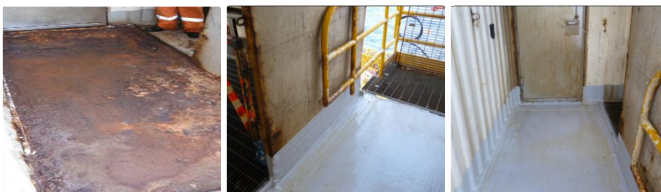
Stork's Composite Repair team proposed to apply PowerSleeve around the circumference of the walls and Bio-Dur 563 to the remaining exposed steelwork on the floor.

At the platform's request, PowerSleeve was applied to both the walls and the floor. A cosmetic paint coating was then applied to the platform's specification.
